Preliminary Report
Accident involving Air India's B787-8 aircraft bearing registration VT-ANB
at Ahmedabad on 12 June 2025

Government of India
Ministry of Civil Aviation
Aircraft Accident Investigation Bureau

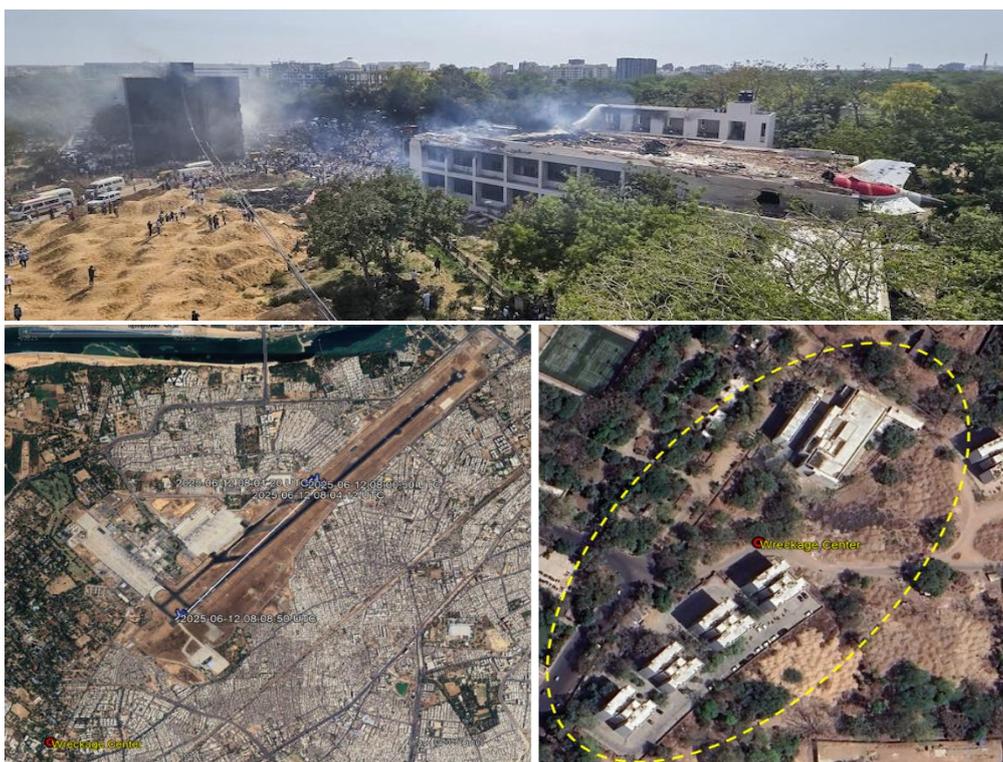
Figure 1 Accident Site with respect to airport (left) and debris field

The Aircraft was destroyed due to impact with the buildings on the ground and subsequent fire. A total of five buildings shown in the figure below were impacted and suffered major structural and fire damages.

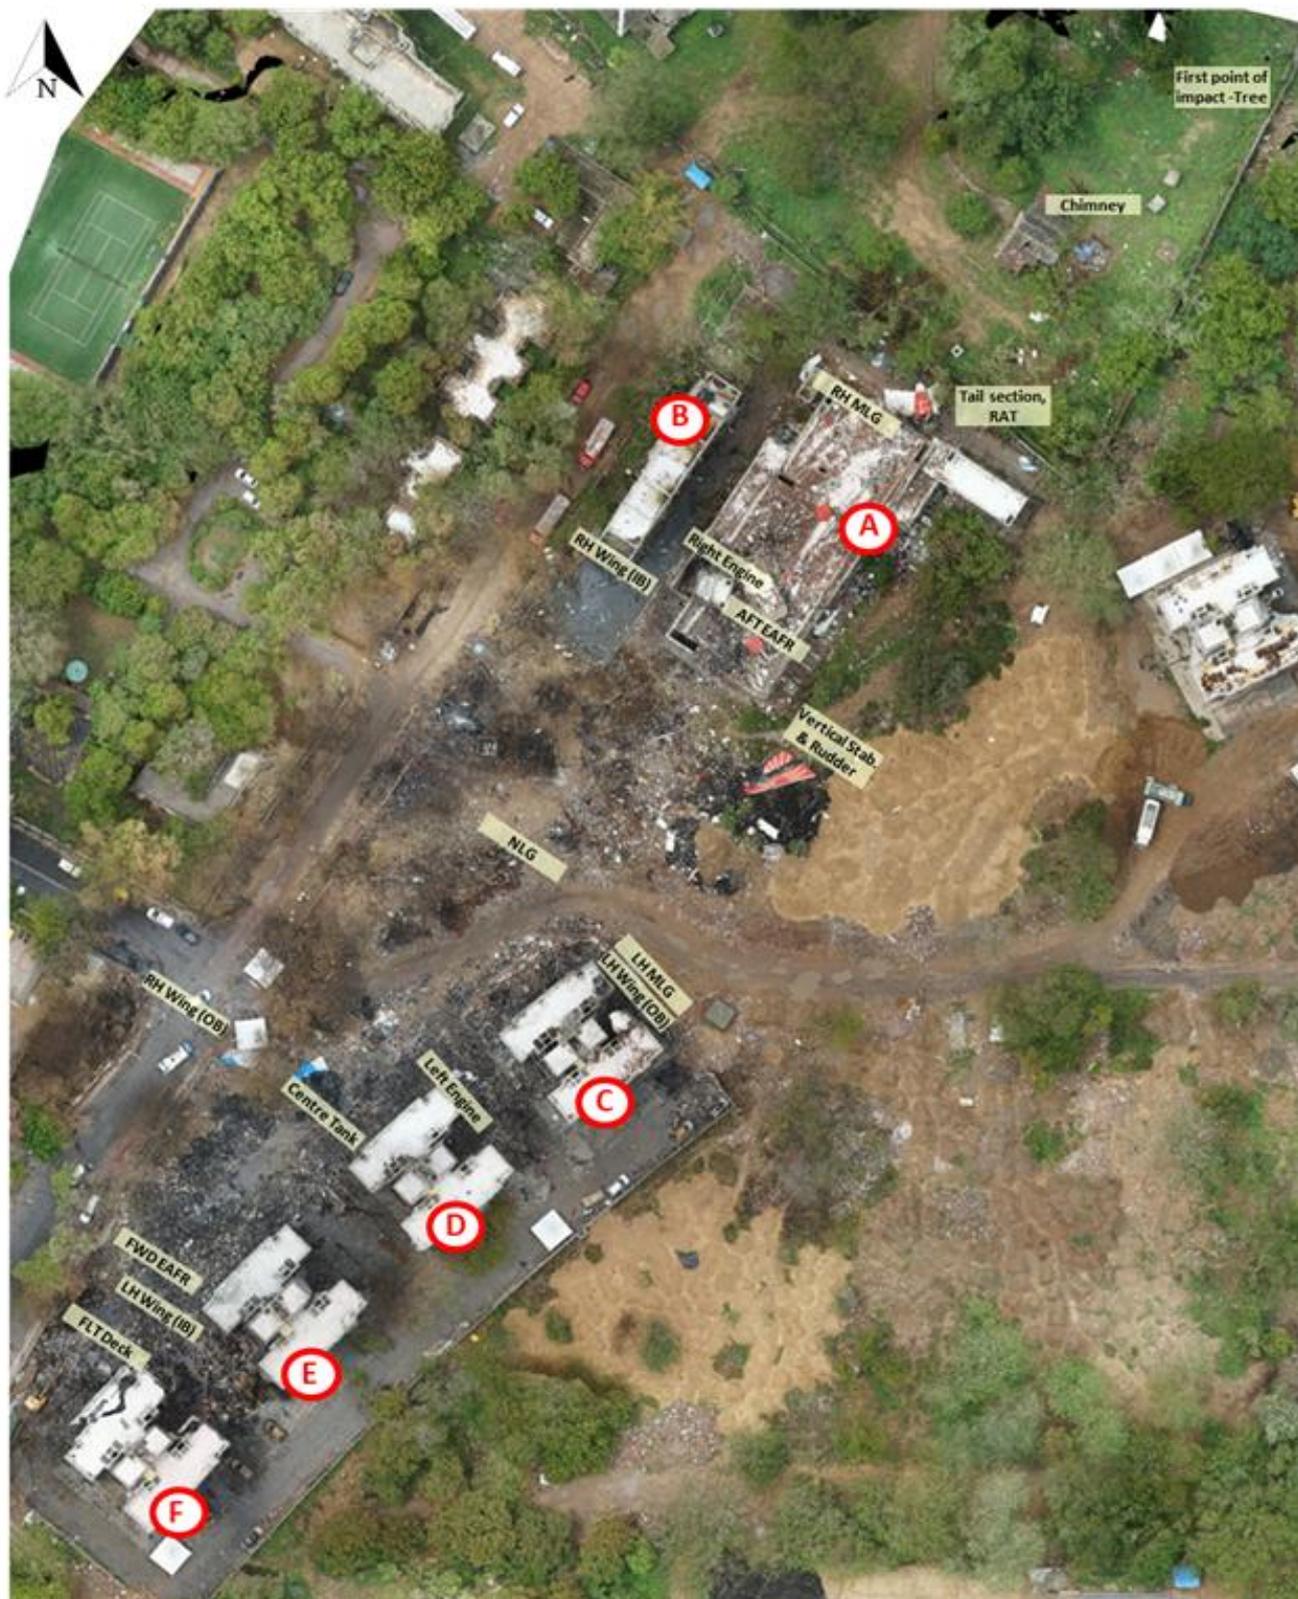
Figure 2 Wreckage layout

After takeoff, the aircraft impacted the BJ Medical College hostel which is 0.9 NM from the departure end of Runway 23. The Emergency Locator Transmitter (ELT) was not activated during this event. The wreckage, from the first impact point till the last identified aircraft item, was distributed in an area of approx. 1000 ft * 400 ft. A layout of the crash site has been given in Fig. 2 indicating the significant parts of the aircraft. The buildings at the wreckage site have been labelled alphabetically from A-F in the layout for easy reference.

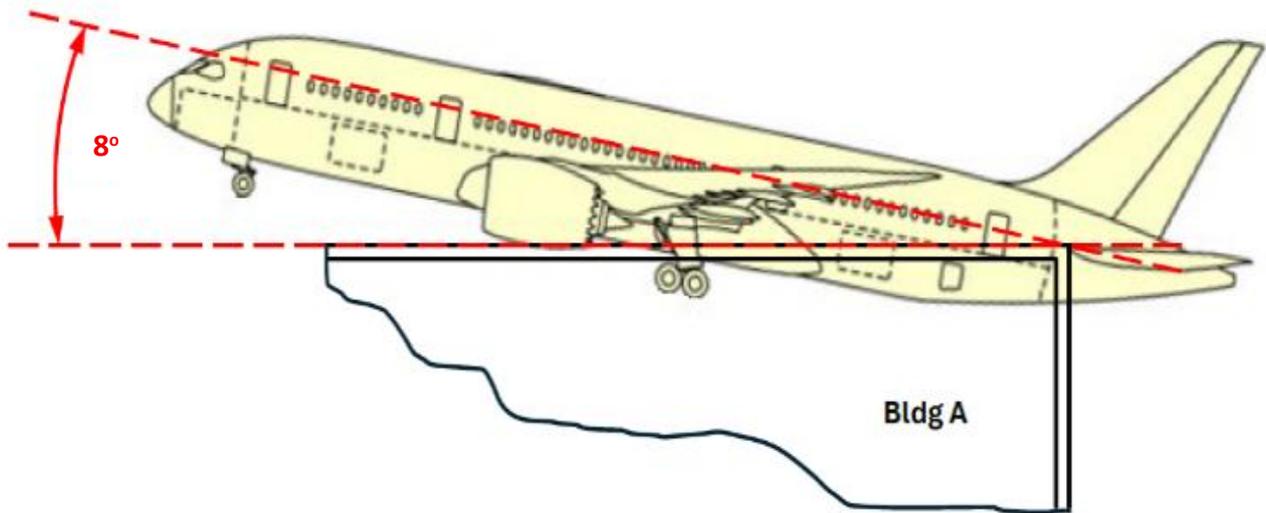
Figure 3 Aircraft attitude at the time of impact with Building A

As the aircraft was losing altitude, it initially made contact with a series of trees and an incineration chimney inside the Army Medical Corps compound before impacting the northeast wall of the Building A. The distance between the tree on which the aircraft made its initial contact and the point on the Building A where the aircraft impacted is 293 ft. As the

aircraft moved forward, it continued fragmenting and collided with other structures and vegetation. The impact witness marks on the building and airplane indicated a likely nose-up attitude (about 8°) and wings level.

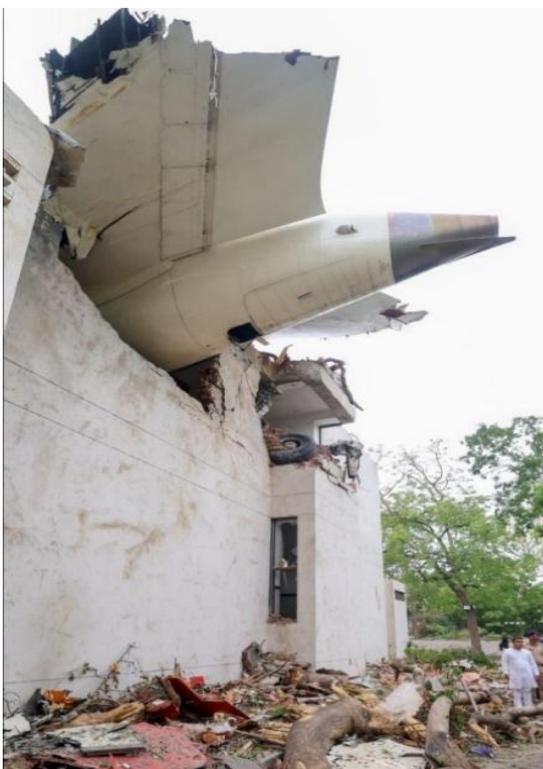
Figure 4 Tail section & RH MLG embedded in the building A

The vertical stabilizer (*fig. 5*) separated from the aft fuselage and came to rest about 200 feet south of the initial point of contact with the Building A. The tail section and the RH Main Landing Gear (MLG) of the aircraft were found embedded in the northeast wall of the Building A while the rest of the airplane continued its forward movement.

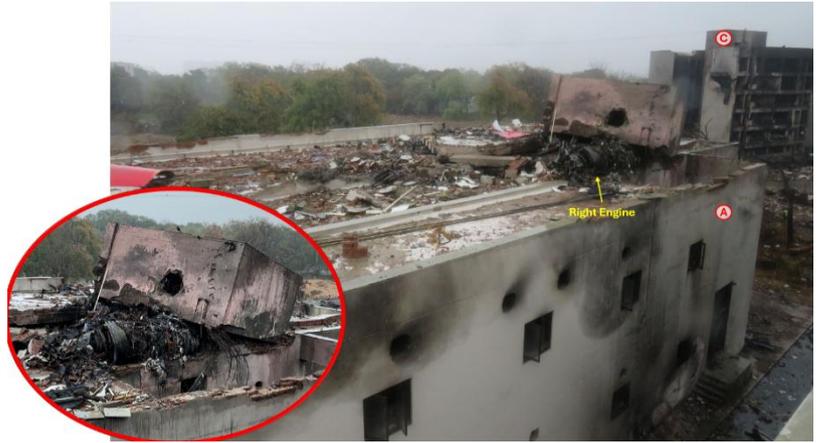
Figure 6 RH Engine

As the airplane continued its path across the roof of the Building A the right engine (fig. 6) struck the concrete water tank structure, separated from the airplane and rested underneath the water tank structure facing a heading of approx. 226 degrees near southwest wall of the Building A.

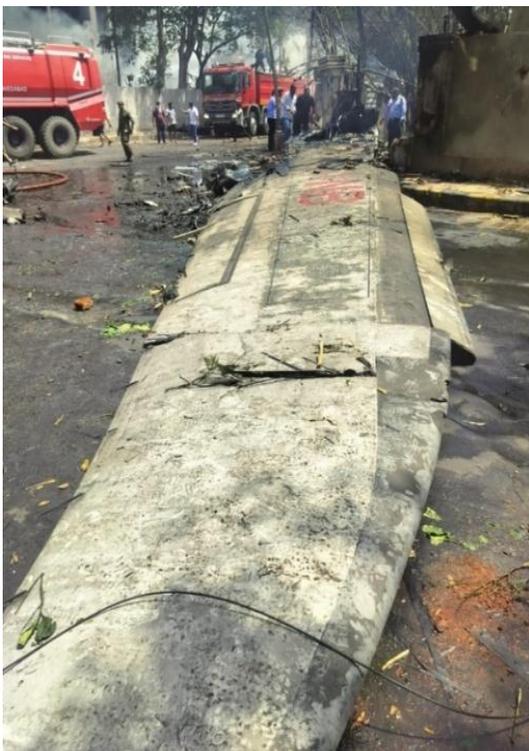
Figure 7 : RH Wing Outboard

The right-wing mid-section and the outboard section (fig.7) was about 280 feet and 520 feet southwest respectively from the initial point of contact with the Building A.

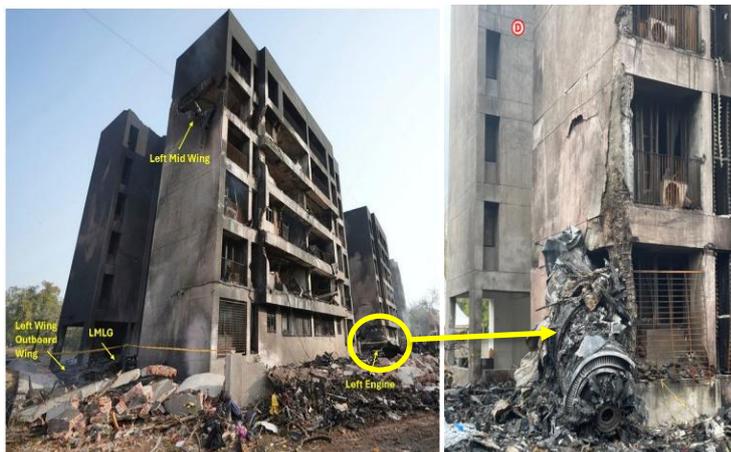
Figure 8 LH Engine

The left engine (fig.8) got separated from the airplane and struck the north corner of Building D at the ground level where it remained and was roughly perpendicular to the right engine resting position, at heading of approx. 326 degrees. The wall was pushed into the

building and the northwest building column was damaged such that portions of the concrete

were missing and exposing the internal metal rebar. The engine, remaining portions of attached cowling, and the surrounding area were heavily damaged by fire.

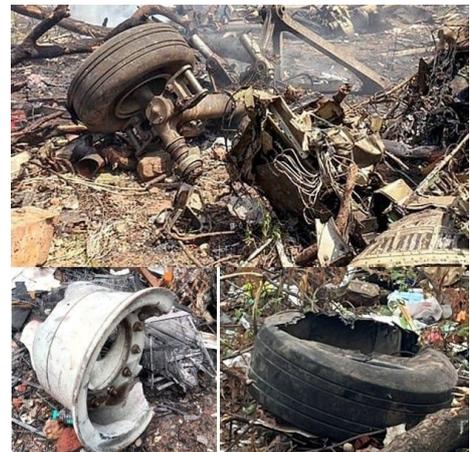
Figure 9 Nose Landing Gear

The nose landing gear (NLG) (fig. 9) was found on the ground about 307 feet southwest from the initial point of contact with Building A.

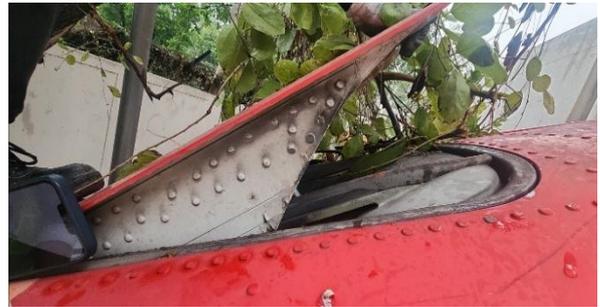
Figure 10 APU Air Inlet Door

After the tail section was brought down, the APU was inspected and found intact inside the APU compartment. The APU air inlet door (fig. 10), which was intact, was found open. The fuselage fragmented and sustained thermal damage as it traveled along the northwest faces of Buildings C, D, E, and F with the furthest debris observed at about 765 feet southwest from the initial point of contact with building A. The flight deck area and windshield support structure came to rest at about 650 feet southwest from the initial point of contact with Building A.

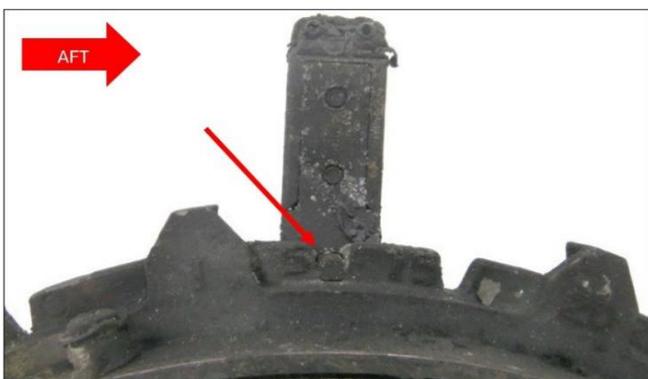
Figure 11 Flap Handle Lever

The flap handle assembly (fig.11) sustained significant thermal damage. The handle was found to be firmly seated in the 5-degree flap position, consistent with a normal takeoff flap setting. The position was also confirmed from the EAFR data. The landing gear lever was in “DOWN” position. (fig.12)

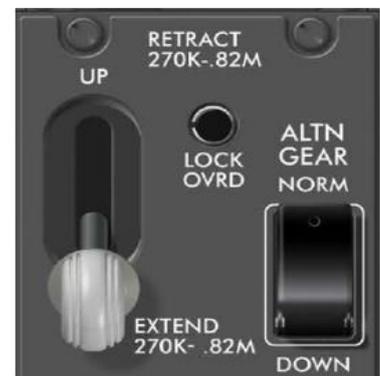
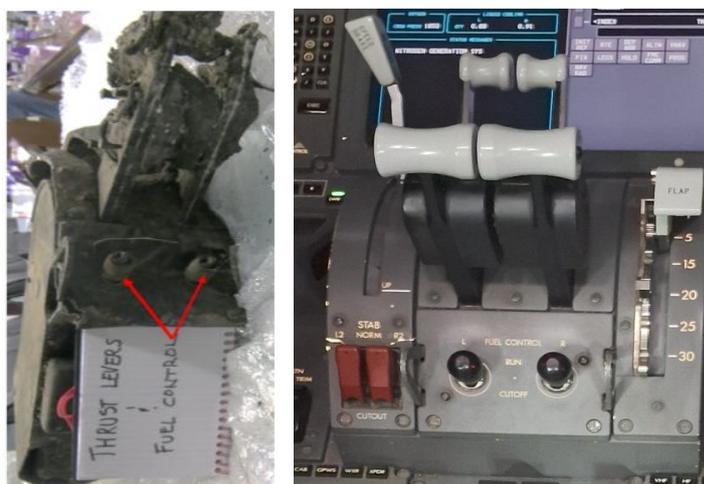
Figure 13 Thrust Lever Quadrant & Fuel Control Switch

The thrust lever quadrant sustained significant thermal damage. Both thrust levers were found near the aft (idle) position. However, the EAFR data revealed that the thrust levers remained forward (takeoff thrust) until the impact. Both fuel control switch were found in the “RUN” position. (fig.13) The reverser levers were bent but were in the “stowed” position. The wiring from the TO/GA switches and autothrottle disconnect switches were visible, but heavily damaged.

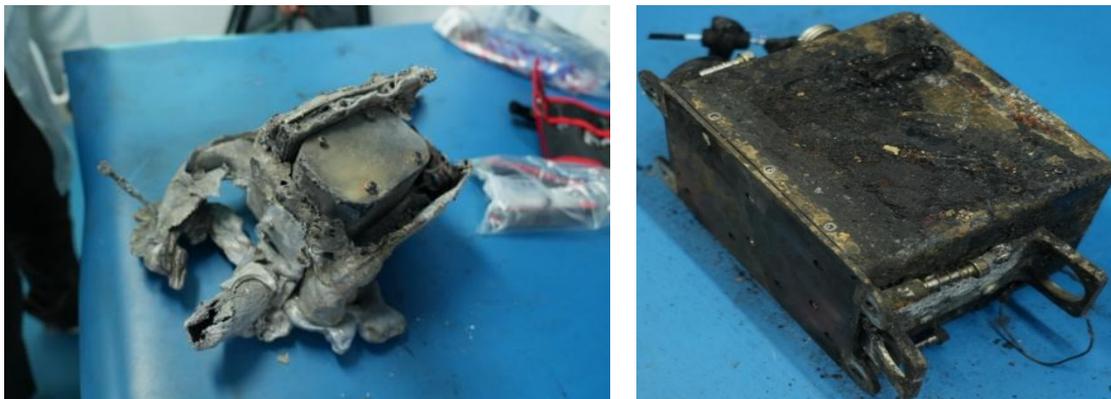
Figure 14 EAFR AFT & FWD

The aft EAFR was located on the roof top of Building A on 13th June 2025. The EAFR had impact and thermal damages to the housing. The wires were protruding from the housing and the connectors were burnt.

The forward EAFR was located on 16th June 2025 from the wreckage debris besides the Building F. The EAFR was burnt and covered in soot. The EAFR was still attached to the

equipment shelf with part of the connector melted but still connected. The ULB was still connected to the housing and the lithium battery was also attached to the equipment shelf, which was removed later prior to transportation.

The aft EAFR was substantially damaged and could not be downloaded through conventional means. The CPM was opened to inspect the memory card. The damage was extensive.

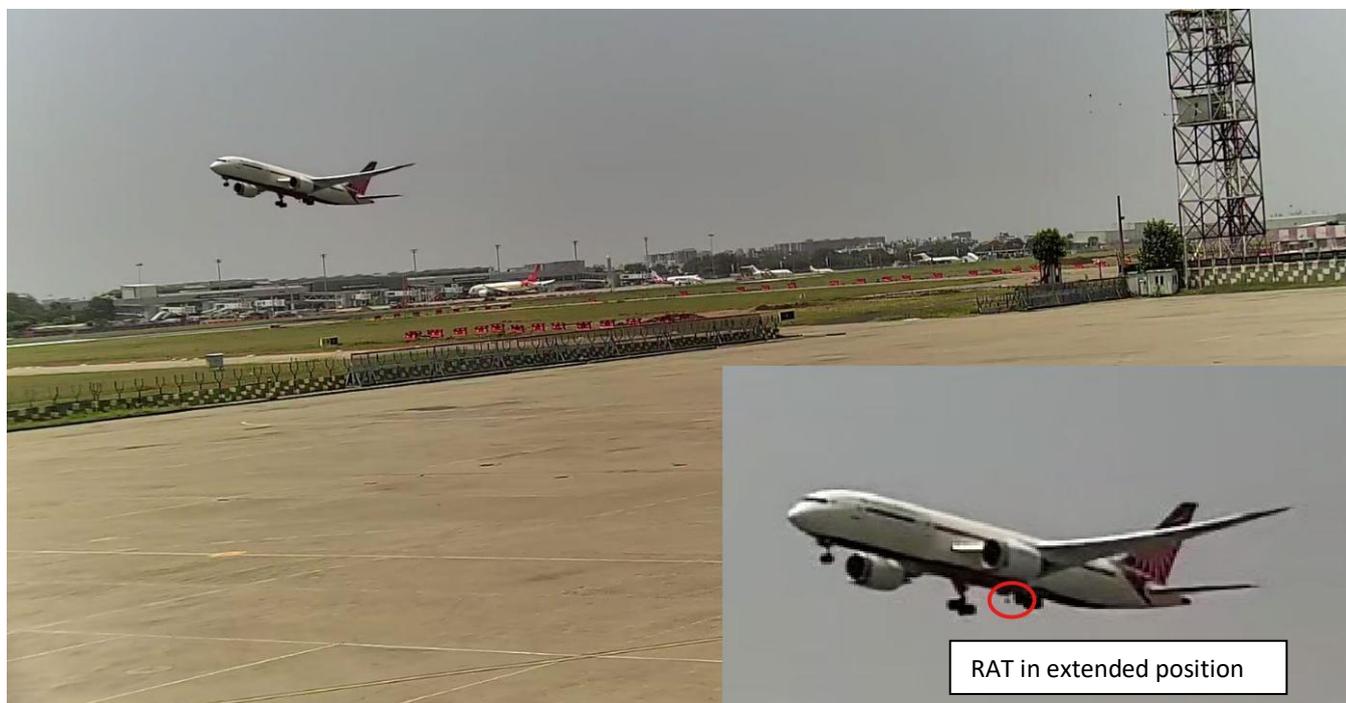
Figure 15 CCTV screenshot of RAT Deployment

The CCTV footage obtained from the airport showed Ram Air Turbine (RAT) getting deployed during the initial climb immediately after lift-off (*fig. 15*). No significant bird activity is observed in the vicinity of the flight path. The aircraft started to lose altitude before crossing the airport perimeter wall.
